# Manhole Inspection Summary

Manhole # S37G\_\_002MH

Insp Date: **11/18/08 11:18 AM**

**Location** Address: **15 guilford st**

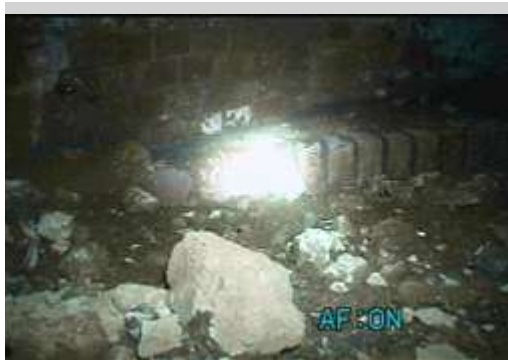
Defect 3

Condition: ☐ Sound ☐ Cracked ☐ Root Intrusion ☐ Deteriorated ☐ Leaks ☒ **Debris**

bench debris

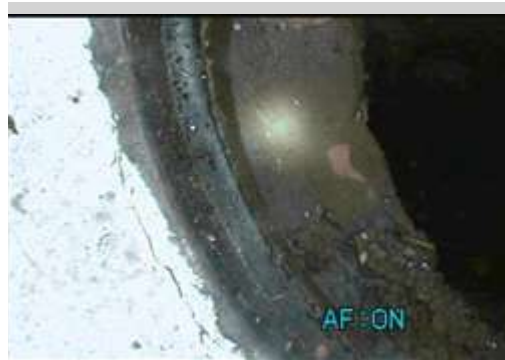
Defect 2

Offset: **6** (in.)

Infiltration: ☐ None ☒ **Joint** ☐ Cracks ☐ Mortar ☐ Roots ☐ Wall

Frame Offset, Chimney/Frame Infiltration

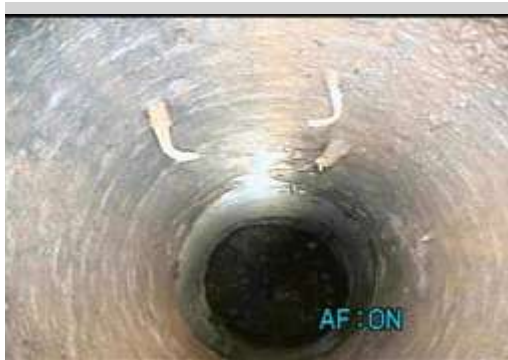
Defect 1

Condition: ☐ Sound ☐ Cracked ☐ Root Intrusion ☐ Loose Brick ☒ **Deteriorated**

Count: **9** Missing: **9** ☒ **Corroded**

Corroded Steps, Deteriorated Chimney,  
Chimney Infiltration

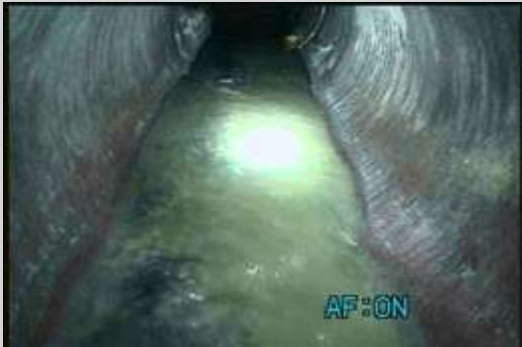
12 O'Clock Outflow

12 in. Circular Gravity Sewer  
Pipe Out @ 12 O'Clock

Invert Depth: **18.20** (ft.) Flow Characteristics: **Slow**

Infiltration: **None** Pipe Seal Cond: **Unknown**

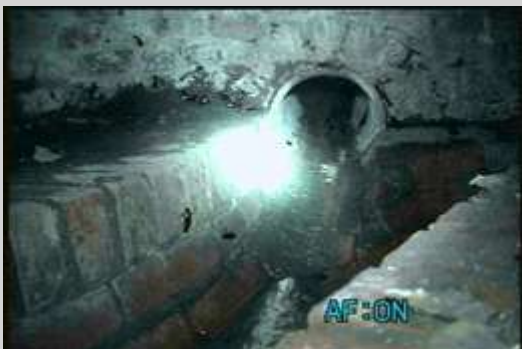
6 O'Clock Inflow

12 in. Circular Gravity Sewer  
Pipe In @ 6 O'Clock

Invert Depth: **18.16** (ft.) Flow Characteristics: **Slow**

Infiltration: **None** Pipe Seal Cond: **Unknown**

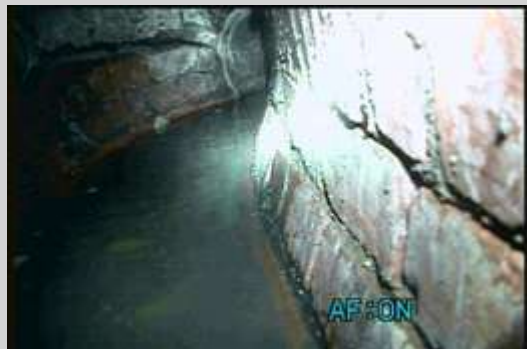
9 O'Clock Inflow

12 in. Circular Gravity Sewer  
Pipe In @ 9 O'Clock

Invert Depth: **17.88** (ft.) Flow Characteristics: **Slow**

Infiltration: **None**
